NPIC/CSD 558/65

4 NOVEMBER 1965

ROUTE 12
MU GIA PASS AREA, LAOS

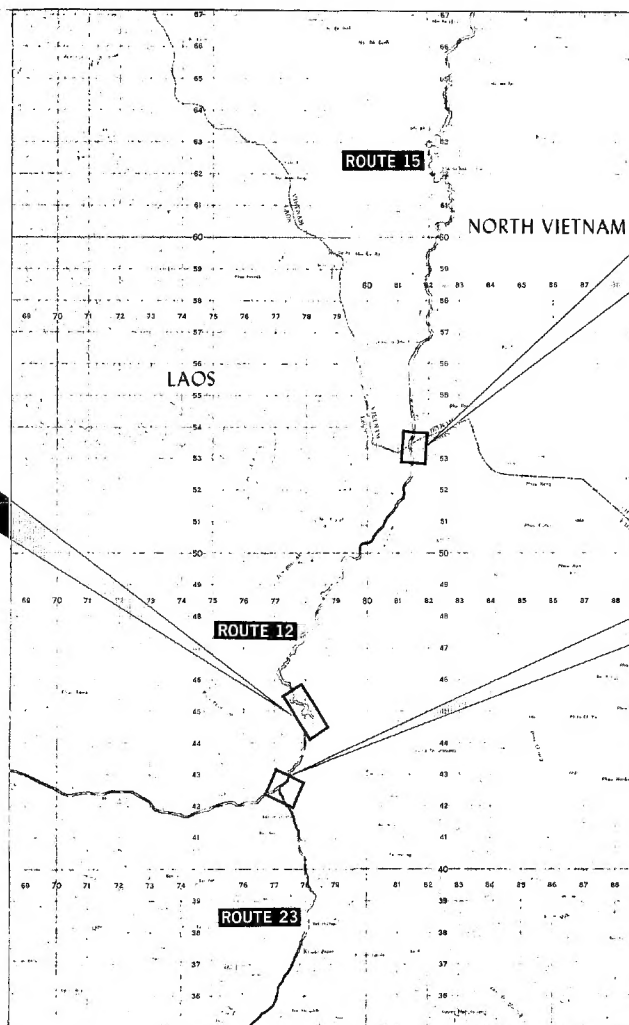
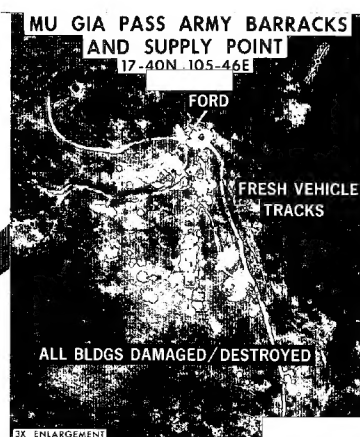
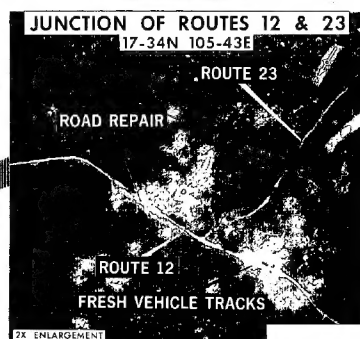
ROUTE 12 MU GIA PASS AREA, LAOS

3. [REDACTED] REVEALS ROUTE 12 IN THE MU GIA PASS AREA TO BE SERVICEABLE FOR VEHICLE TRAFFIC FROM THE MU GIA PASS ARMY BARRACKS AND SUPPLY POINT [REDACTED] AT 1740N 10546E TO THE JUNCTION OF LAOTIAN ROUTES 12 AND 23 AT 1734N 10543E. THE MU GIA PASS CHOKE POINT, LOCATED 4.9 NM SOUTH-SOUTHWEST OF THE BORDER AT 1735N 10544E, HAS UNDERGONE EXTENSIVE REPAIRS TO THE AREAS OF INTERDICTION. ALL INTERDICTION POINTS HAVE BEEN FILLED OR BY-PASSED AND VEHICLE TRACKS ARE NOTED THROUGHOUT THE IMAGED PORTION OF ROUTE 12. ALL BUILDINGS AT THE MU GIA PASS ARMY BARRACKS AND SUPPLY POINT HAVE BEEN DAMAGED OR DESTROYED.
